# Hospital de Emergencia Dr Clemente Álvarez ( Rosario) *HECA*

## Signo de la Manzana Mordida

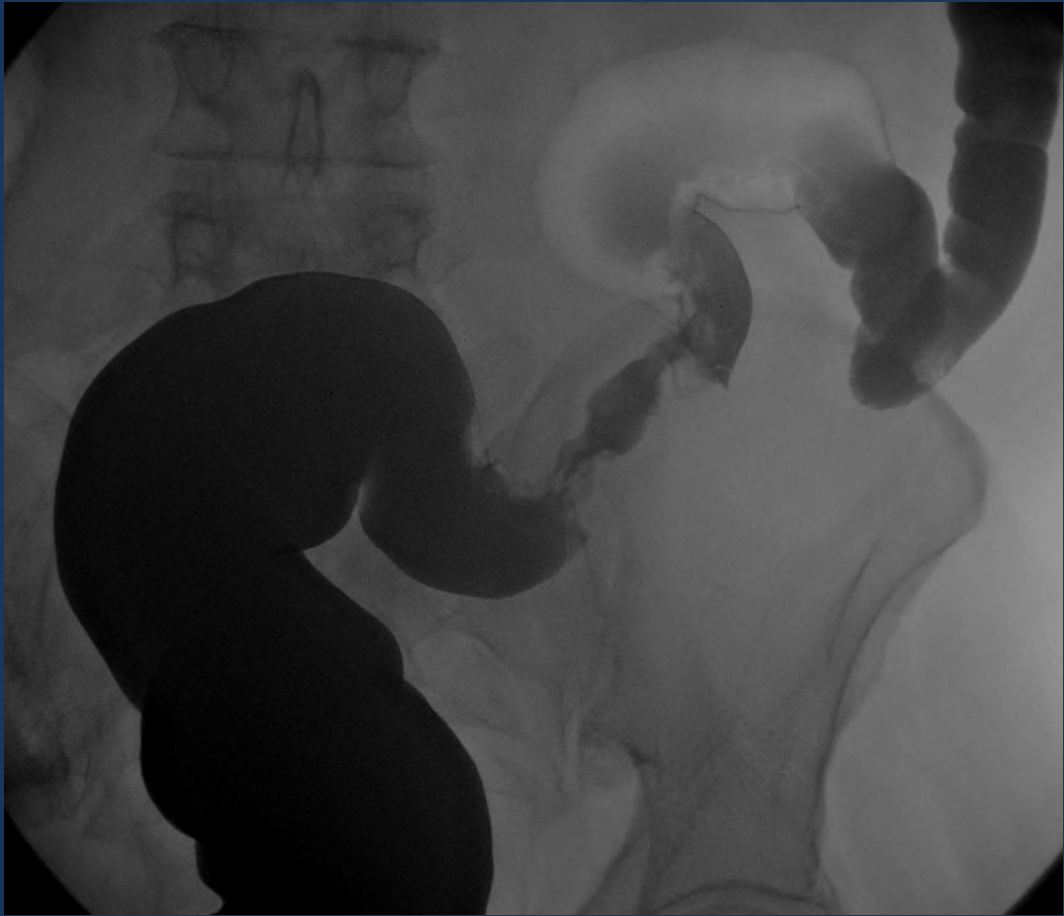
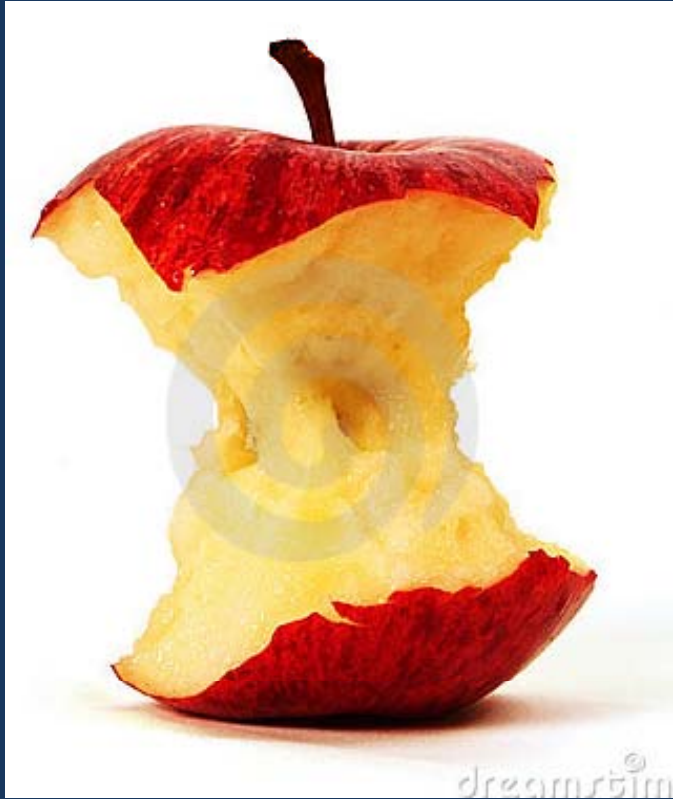
✓ **Descripción del signo – Hallazgos Radiológicos en el Colon por Enema :**

- Imagen de resta - estenosis segmentaria - pasaje filiforme de la sustancia de contraste.
- Comienzo abrupto - hombros de la lesión.
- Irregularidad - asimetría de la mucosa.
- Engrosamiento de los pliegues mucosos.
- Pérdida del ribete de seguridad.
